# **A Guide to Can Defects and Basic Components of Double Seam Containers**

**November 2011**

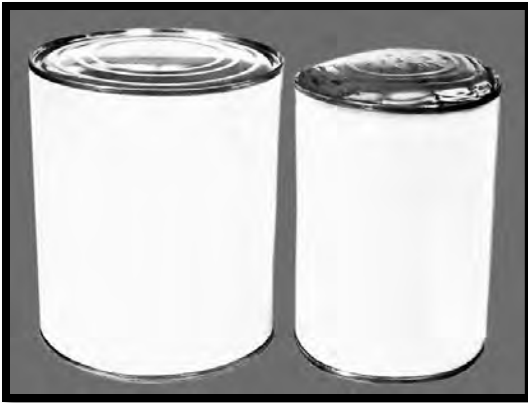
**Photo 1:** *Bulged and/or swollen ends from gas formation in can which causes one or both ends to swell producing a flipper, soft swell, hard swell, or blown can.*

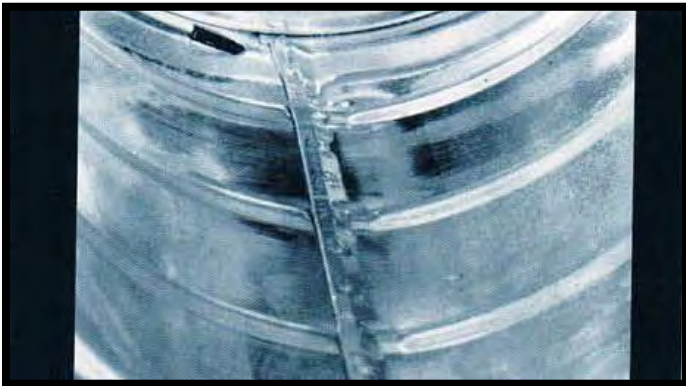
**Photo 2:** *Can with likely loss of hermetic seal and normally a leader due to the mislocked side seam.*

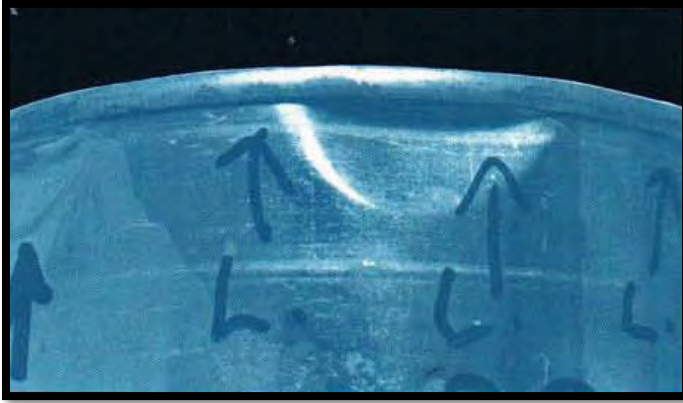
**Photo 3:** *An opening below the double seam or plate fracture.*

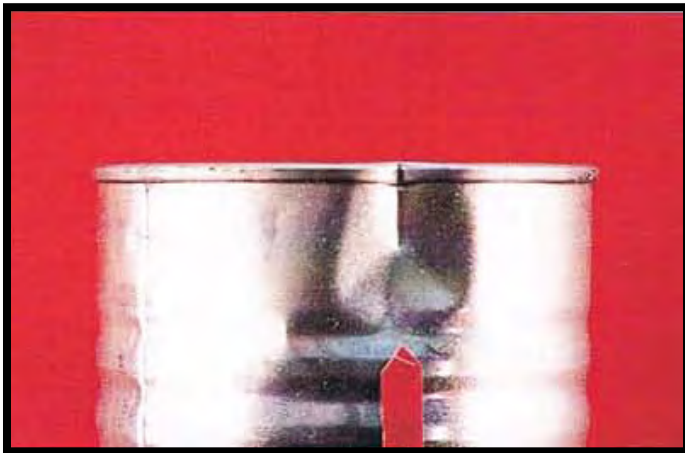
**Photo 4:** *Plate fracture in double seam or can body. Note position of red pointer.*

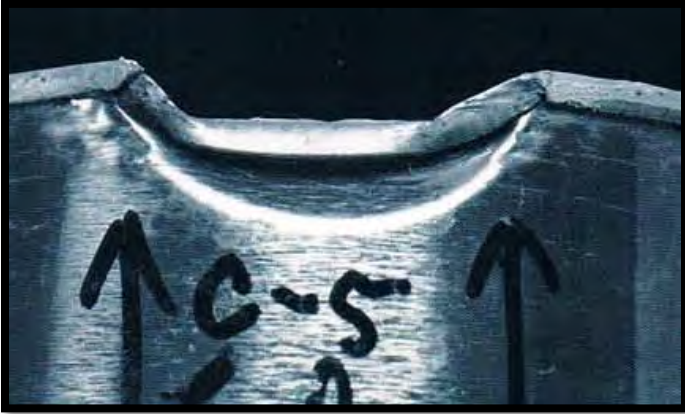
**Photo 5:** Severe double seam dent plate fracture.

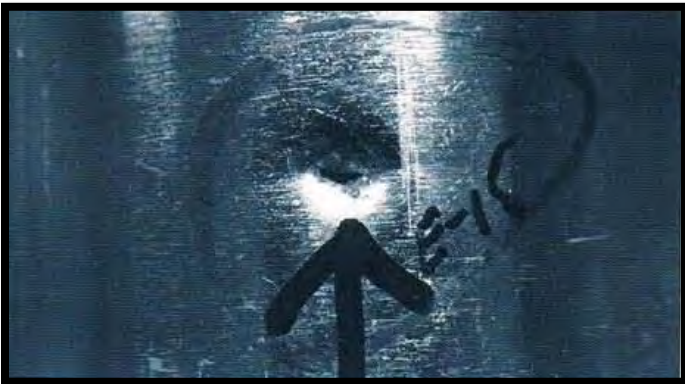
**Photo 6:** Puncture in can body. Pinholes in can body plate also cause loss of hermetic seal.

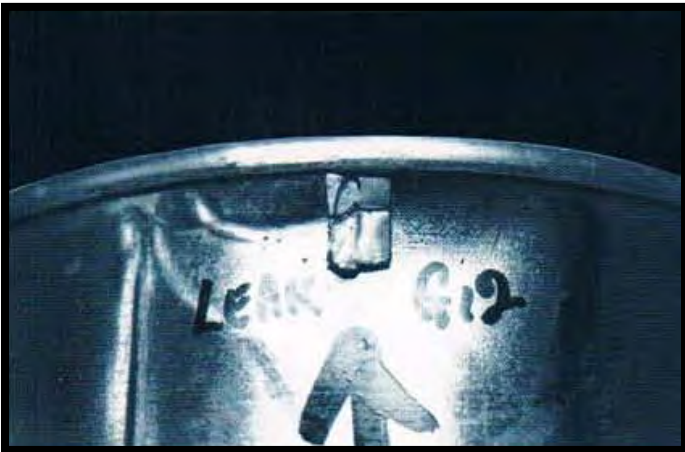
**Photo 8:** Defect in end of closure on can (torn flange). Note arrow pointer.

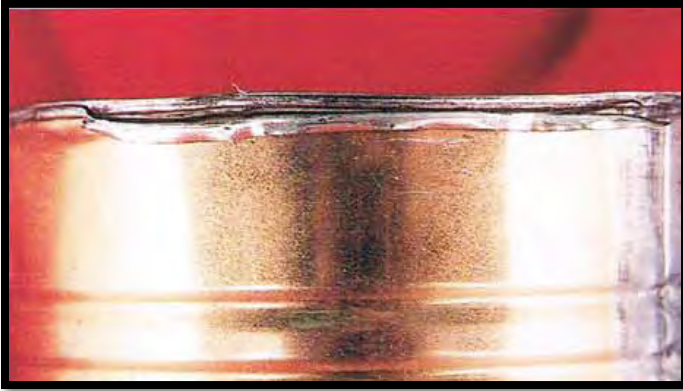
**Photo 9:** Depicts a **false seam** with loss of hermetic seal. Seam is formed but not engaged properly. Note knocked down flange.

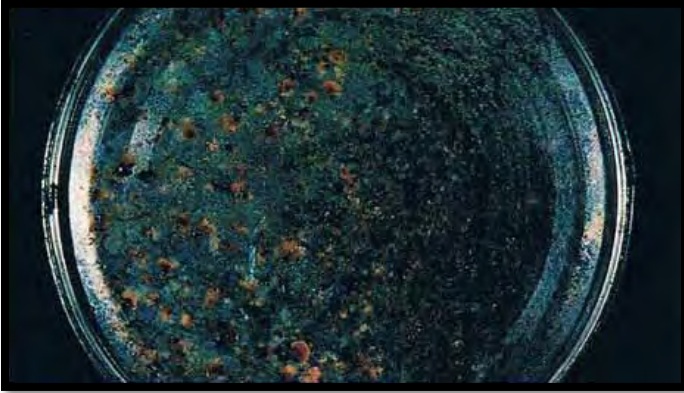
**Photo 11:** *Severely rusted with deep pits near point of perforation.*

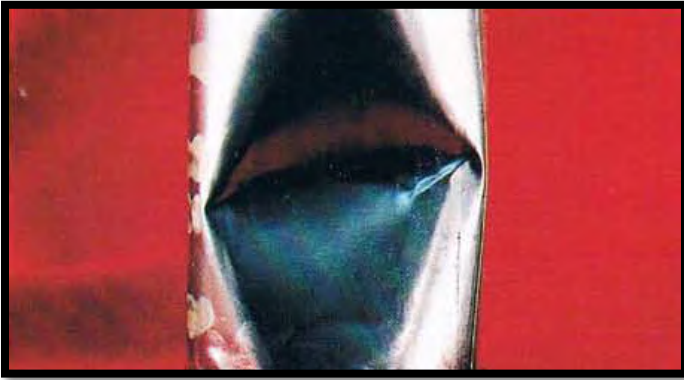
**Photo 13:** Major dent in center of can body. (Plate may be fractured with loss of hermetic seal.)

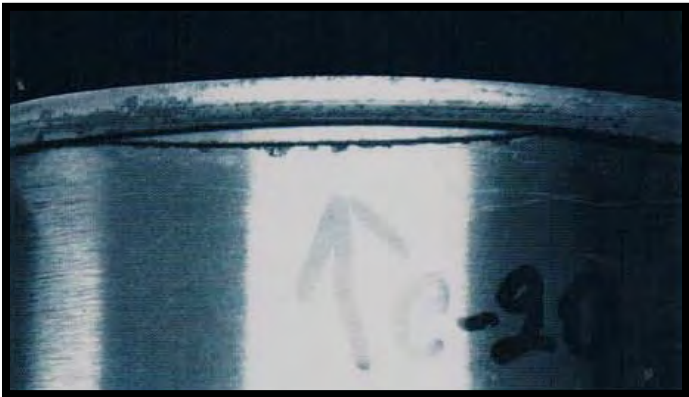
**Photo 16:** Pointer indicates “knocked down flange.”

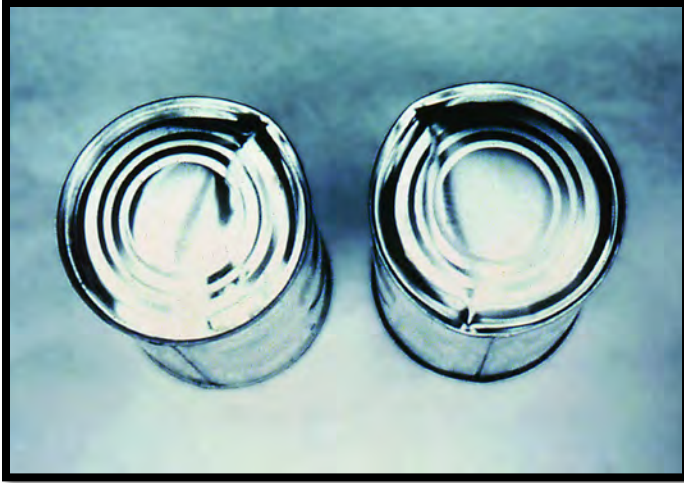
**Photo 17:** Cans that are buckled during retorting may leak during the cooling operation because the double seam has been strained.

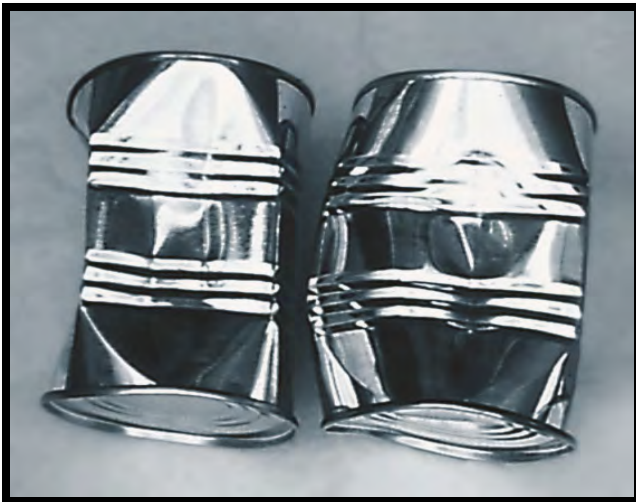
**Photo 18:** Cans exhibiting severe paneling of the side walls.

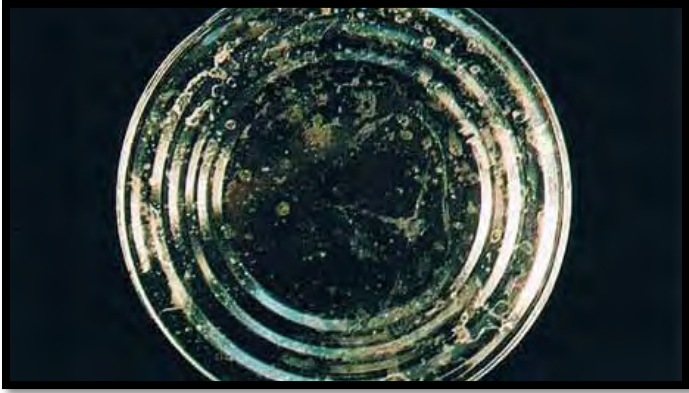
**Photo 19:** Surface rust and residue food cooked on end of can. (Minor external rust and light superficial pitting easily removable by light buffing is considered an insignificant defect).

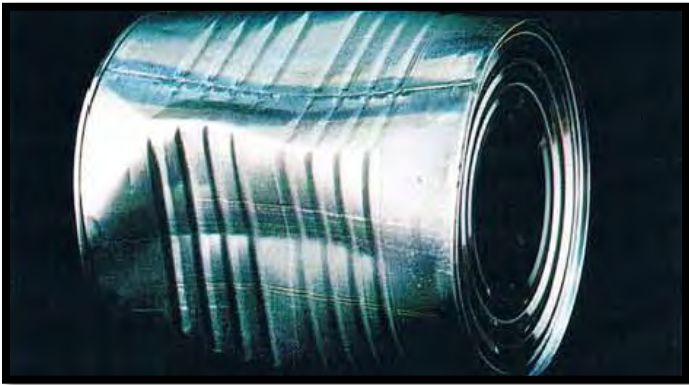
**Photo 20:** Paneled container without visible signs of loss of integrity, i.e., no plate fractures.

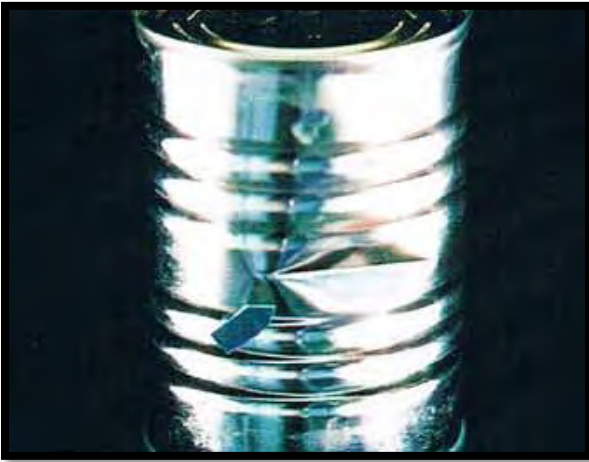
**Photo 21:** *Obvious body dent on side of container body. Side seam and/or double seams appear not significantly affected.*

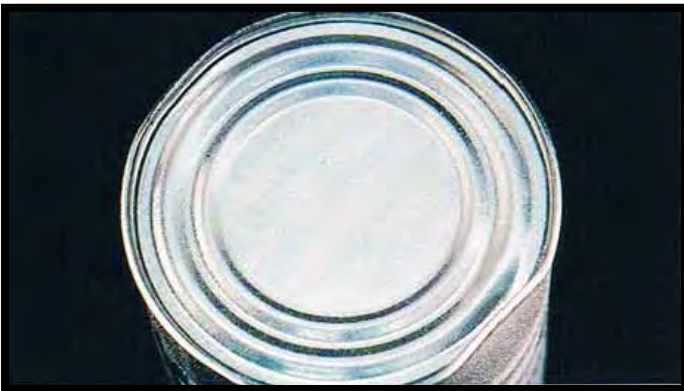
**Photo 22:** *Minor dent to double seam on end of can body, i.e., it does not appear creased or sharp.*

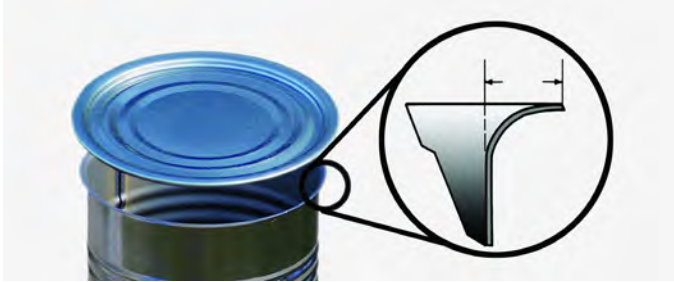
**Figure 1**

The **flange** is the edge of the body cylinder that is flared outward resulting in a rim or ledge and is an integral part of the double seam. The flange is formed into the body hook during double seaming and becomes interlocked with the cover hook. The width and radius of the flange are determined by can manufacturers to meet the requirements of forming a proper body hook during the double seaming operation (*Figure 1*).

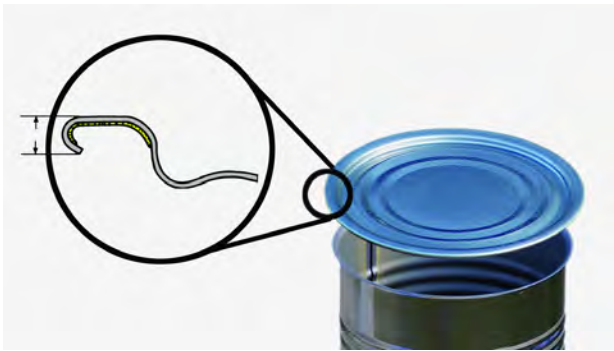
**Figure 2**

The **end curl** -- sometimes referred to as cover curl -- is designed to provide sufficient metal to form a good cover hook. Important in the design are proper curl, a proper base for sealing compound application, and easy feeding of end units into the closing machine (*Figure 2*).

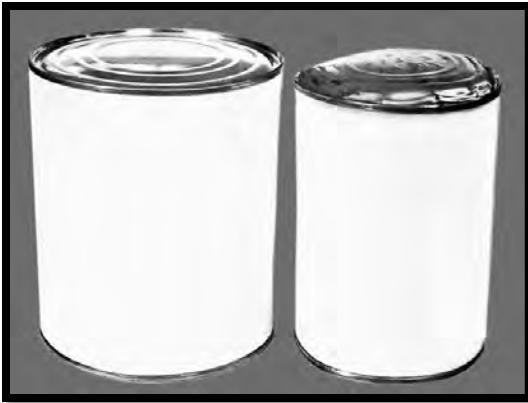
**Photo 1:** *Bulged and/or swollen ends from gas formation in can which causes one or both ends to swell producing a flipper, soft swell, hard swell, or blown can.*

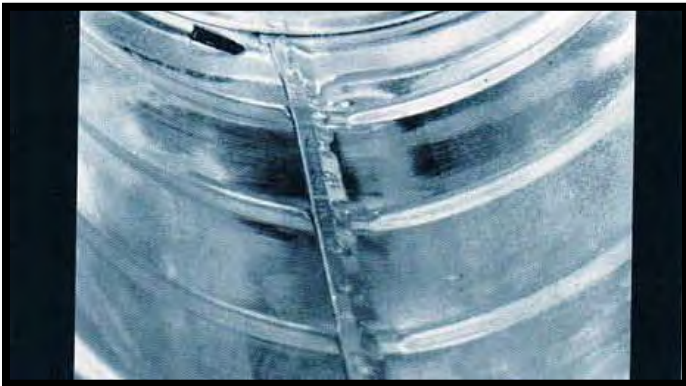
**Photo 2:** *Can with likely loss of hermetic seal and normally a leader due to the mislocked side seam.*

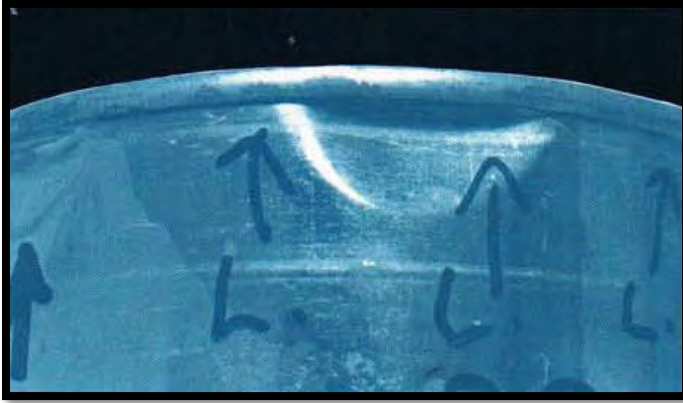
**Photo 3:** *An opening below the double seam or plate fracture.*

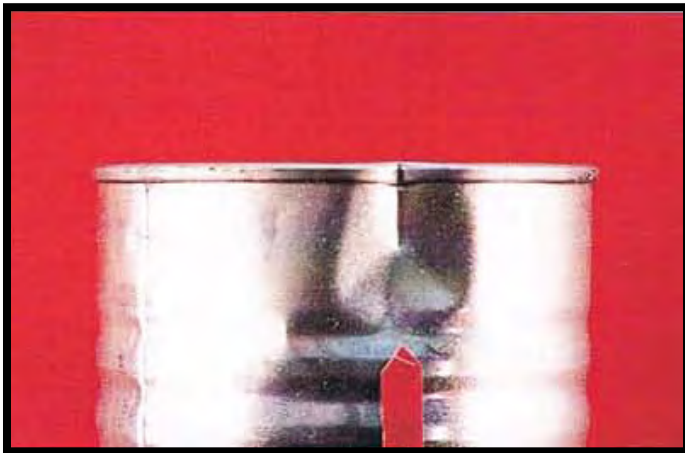
**Photo 4:** *Plate fracture in double seam or can body. Note position of red pointer.*

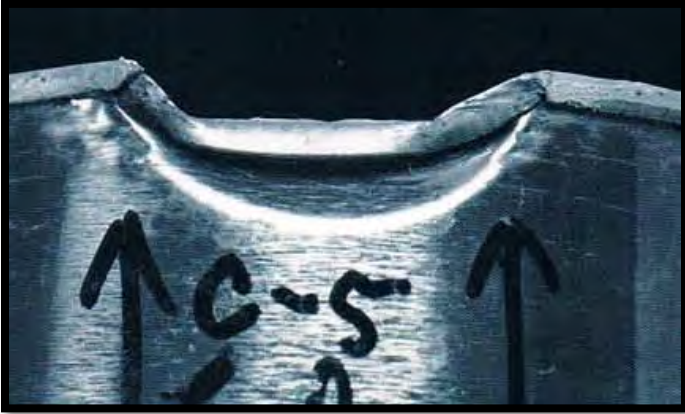
**Photo 5:** Severe double seam dent plate fracture.

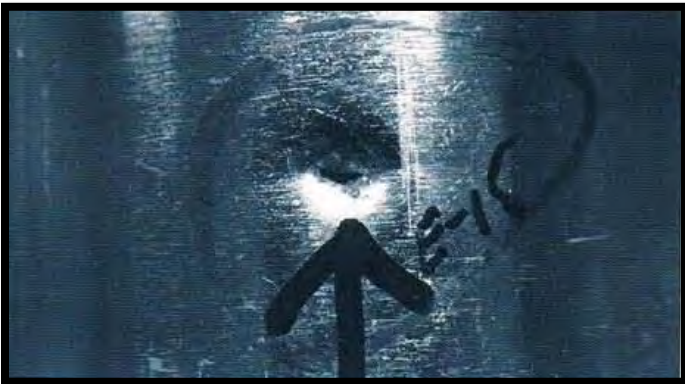
**Photo 6:** Puncture in can body. Pinholes in can body plate also cause loss of hermetic seal.

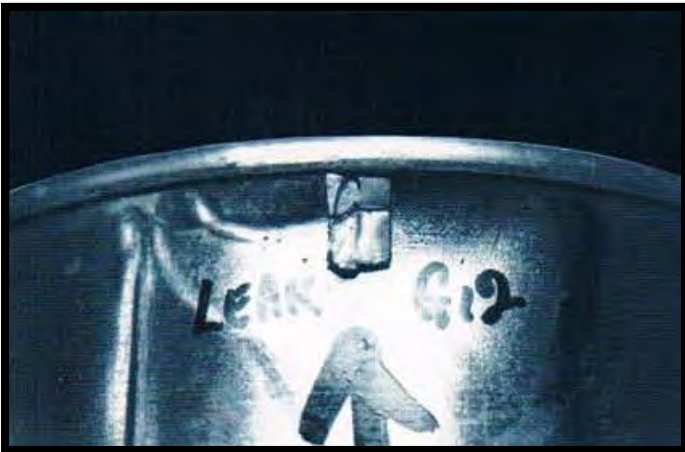
**Photo 8:** Defect in end of closure on can (torn flange). Note arrow pointer.

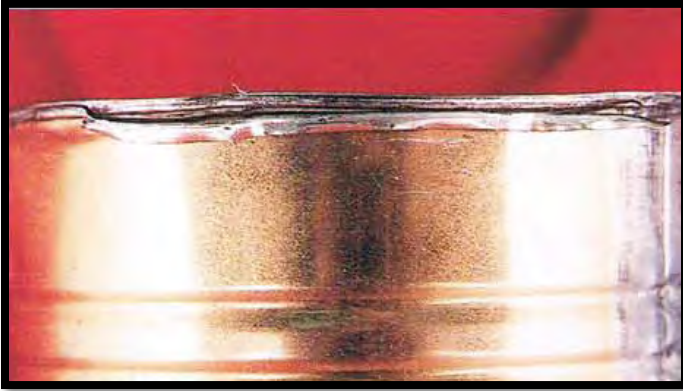
**Photo 9:** Depicts a **false seam** with loss of hermetic seal. Seam is formed but not engaged properly. Note knocked down flange.

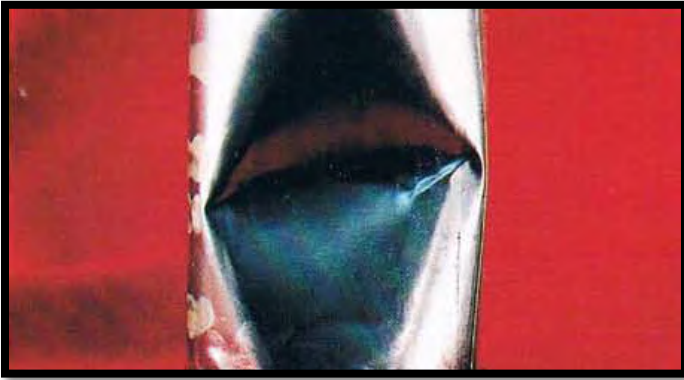
**Photo 13:** Major dent in center of can body. (Plate may be fractured with loss of hermetic seal.)

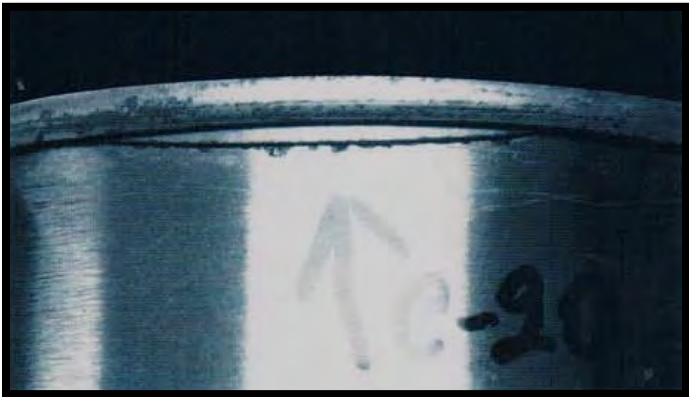
**Photo 16:** Pointer indicates “knocked down flange.”

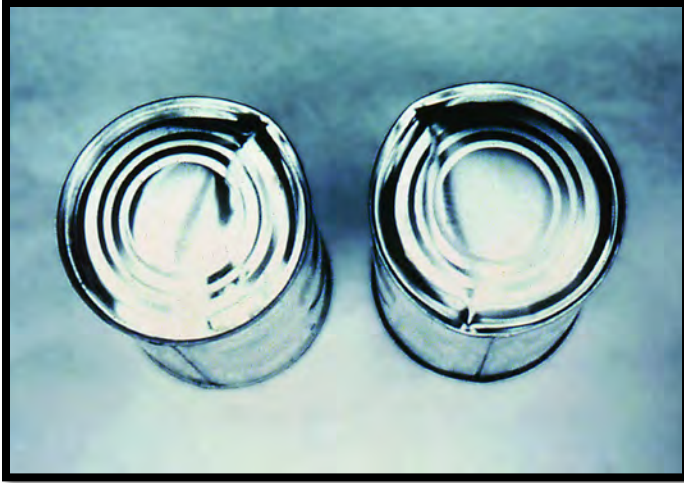
**Photo 17:** Cans that are buckled during retorting may leak during the cooling operation because the double seam has been strained.

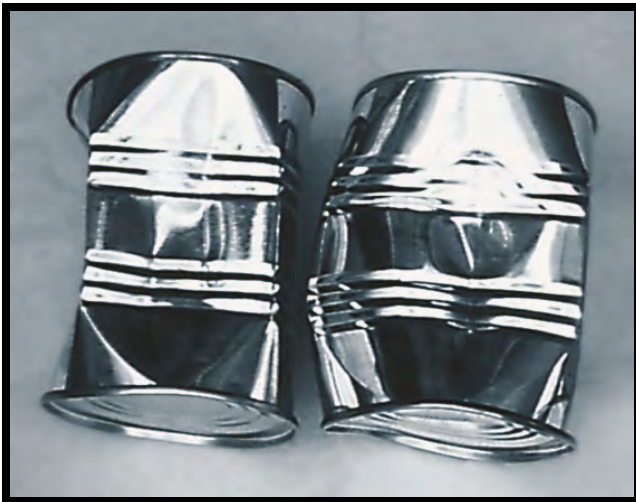
**Photo 18:** Cans exhibiting severe paneling of the side walls.

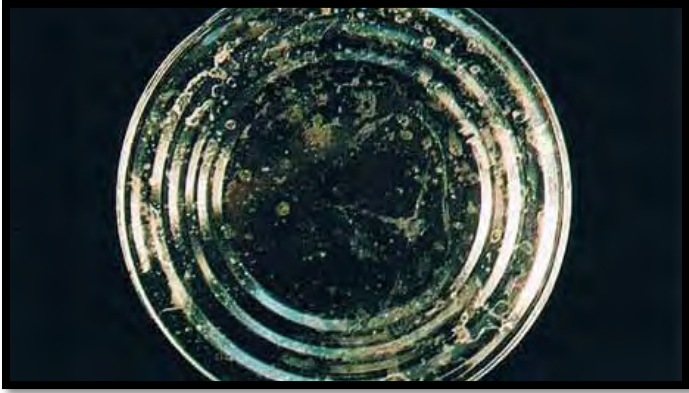
**Photo 19:** *Surface rust and residue food cooked on end of can. (Minor external rust and light superficial pitting easily removable by light buffing is considered an insignificant defect).*

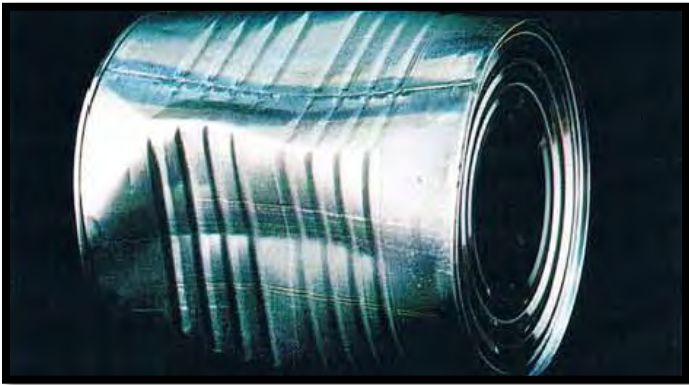
**Photo 20:** *Paneled container without visible signs of loss of integrity, i.e., no plate fractures.*

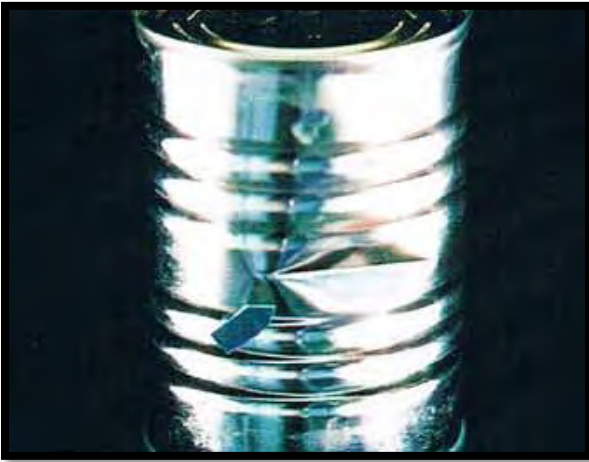
**Photo 21:** *Obvious body dent on side of container body. Side seam and/or double seams appear not significantly affected.*

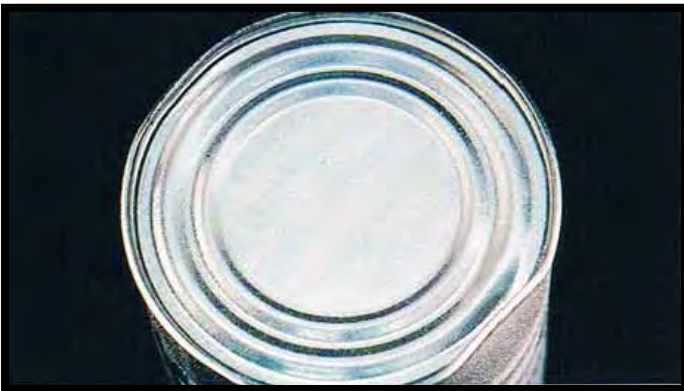
**Photo 22:** *Minor dent to double seam on end of can body, i.e., it does not appear creased or sharp.*

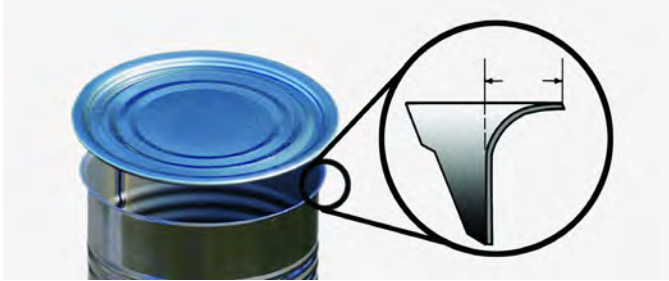
**Figure 1**

The **flange** is the edge of the body cylinder that is flared outward resulting in a rim or ledge and is an integral part of the double seam. The flange is formed into the body hook during double seaming and becomes interlocked with the cover hook. The width and radius of the flange are determined by can manufacturers to meet the requirements of forming a proper body hook during the double seaming operation (*Figure 1*).

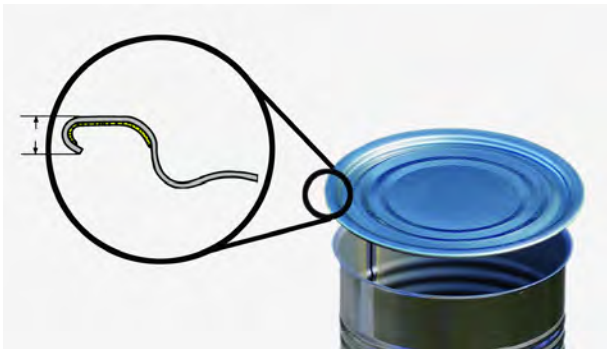
**Figure 2**

The **end curl** -- sometimes referred to as cover curl -- is designed to provide sufficient metal to form a good cover hook. Important in the design are proper curl, a proper base for sealing compound application, and easy feeding of end units into the closing machine (*Figure 2*).
